Manhole Inspection Summary

Manhole # S39YY_010MH

Insp Date: **12/14/06 11:58 AM**

Location Address: **718 GORSUCH AVE**

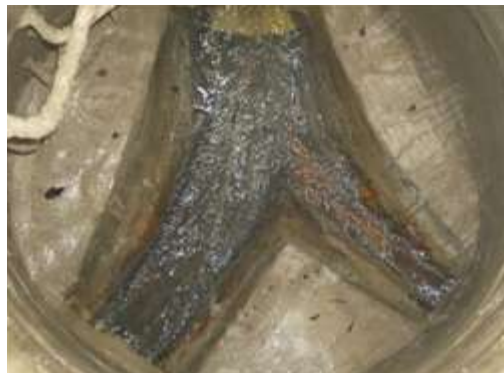
Top View

Infiltration: ☐ None ☒ **Joint** ☐ Cracks ☐ Mortar ☐ Roots ☒ **Wall**

Corbel infiltration.

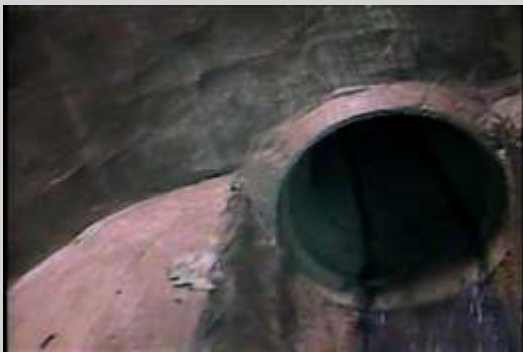
15 in. Circular Gravity Sewer Pipe Out @ 12 O'Clock

Pipe Material: **Unknown** ☒ Pipe Lined

Invert Depth: **11.40** (ft.) Flow Characteristics: **Slow**

Infiltration: **None** Pipe Seal Cond: **Unknown**

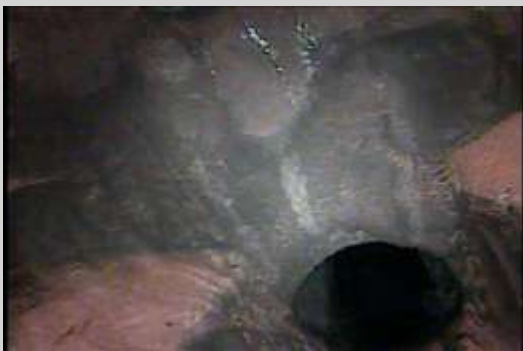
8 in. Circular Gravity Sewer Pipe In @ 4 O'Clock

Pipe Material: **Clay** ☐ Pipe Lined

Invert Depth: **10.87** (ft.) Flow Characteristics: **Slow**

Infiltration: **None** Pipe Seal Cond: **Unknown**

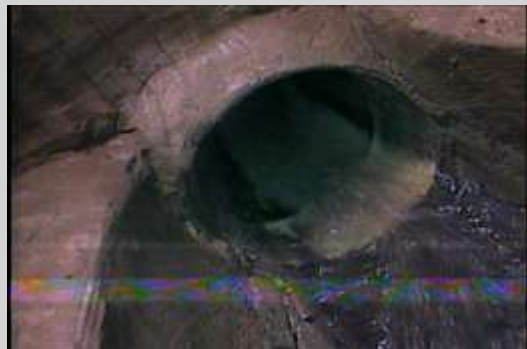
15 in. Circular Gravity Sewer

Pipe Material: **Unknown**

☒ Pipe Lined

Infiltration: **None**
